THE SEWERAGE AND WATER BOARD OF NEW ORLEANS

CARROLLTON WATER PLANT TURBINE GENERATOR 5 EXPLOSION INCIDENT December 14, 2019 CAUSAL ANALYSIS AND RECOMMENDATIONS FINAL REPORT

30 November 2020 PS-**4429639** Contract: 0001505

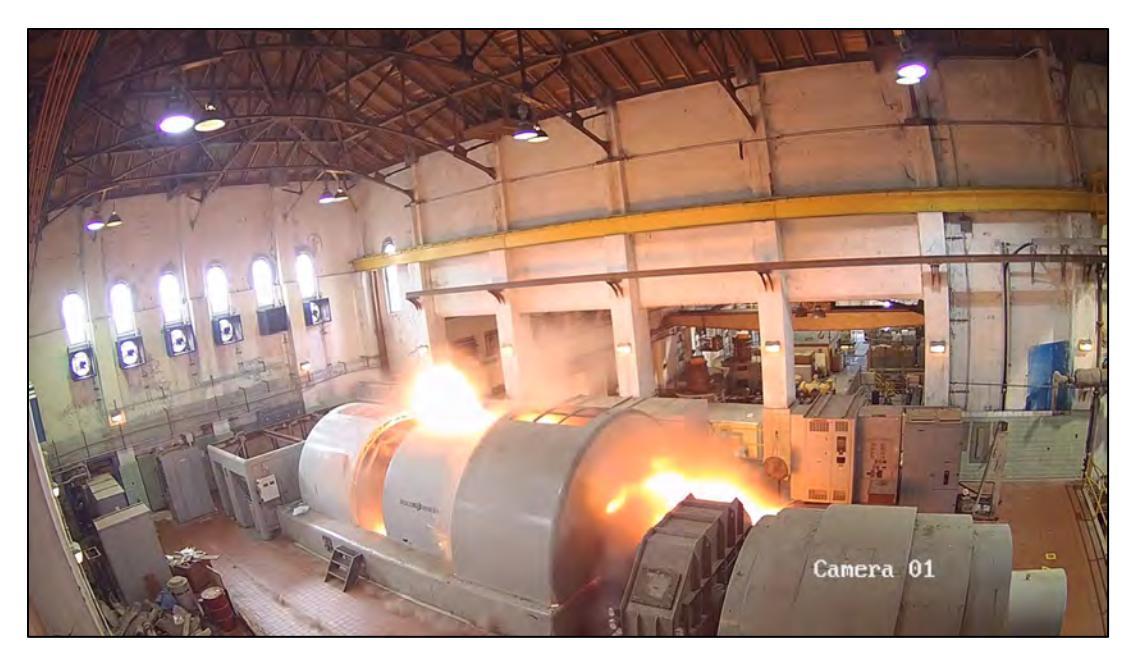
Figure 26. Turbine Generator 5 Explosion December 14, 2019 14:37:30

On December 14, 2019 at approximately 13:47 hours, an explosion during the startup attempt of TG 5 occurred at the SWBNO's Carrollton Water Plant. During the first firing attempt, TG 5 exploded resulting in the damage to the turbine, injuries to the operators in the vicinity of the turbine, and damage to nearby community residential structures as a result of the incident. As of the writing of this report TG 5 remained out of service. The fireball emanating from TG 5 casing is shown in Figure 26 and the fireball emanating from the exhaust stack is shown in Figure 27.

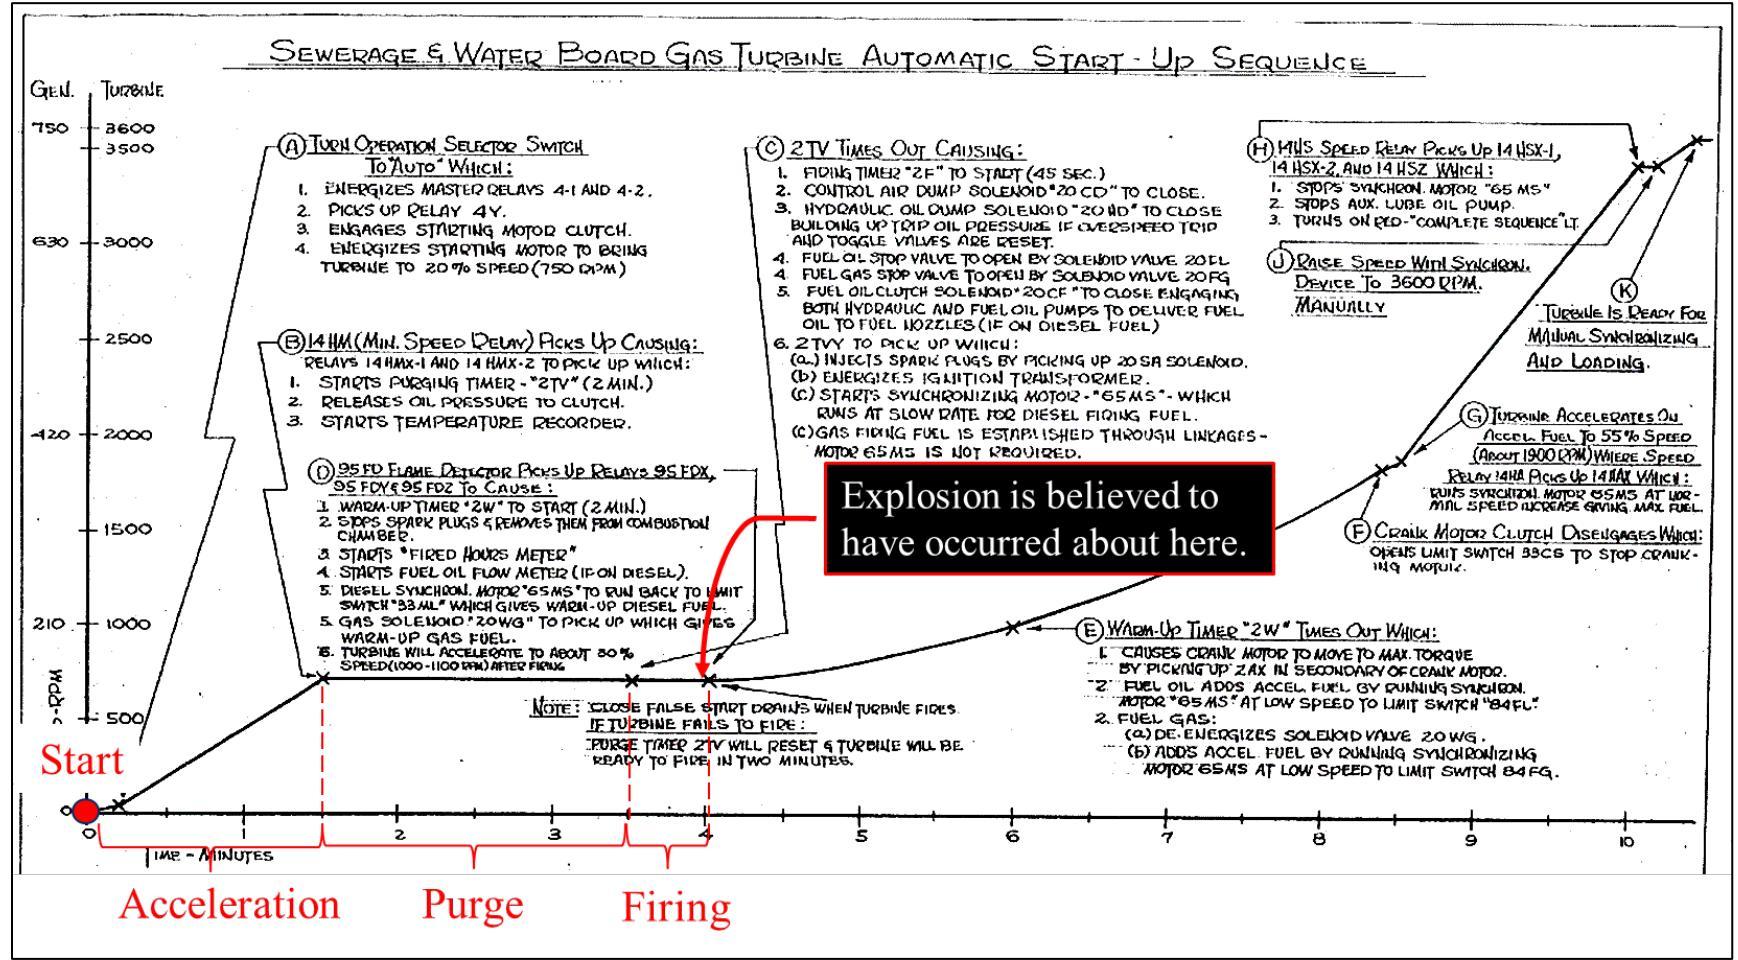
Figure 29. Approximate Time of Explosion During the Start-up Sequence

A copy of the Central Control log remarks from December 14, 2019 are provided in Figure 28. The log remarks state that TG 5 was rolled for start-up at 13:38 and the explosion was logged at 13:45. Although the log entry states 13:38 as the time of TG 5 roll, video footage of both Boiler Control and Central Control are consistent with a final call to start the turbine at 13:42, approximately 5 ½ minutes prior to the TG 5 explosion at 13:47:30. The explosion log entry was made (as indicated by the Central Control video) at 13:56 and incorrectly noted the time of the incident as 13:45 rather than 13:47:30 as indicated by numerous security videos.

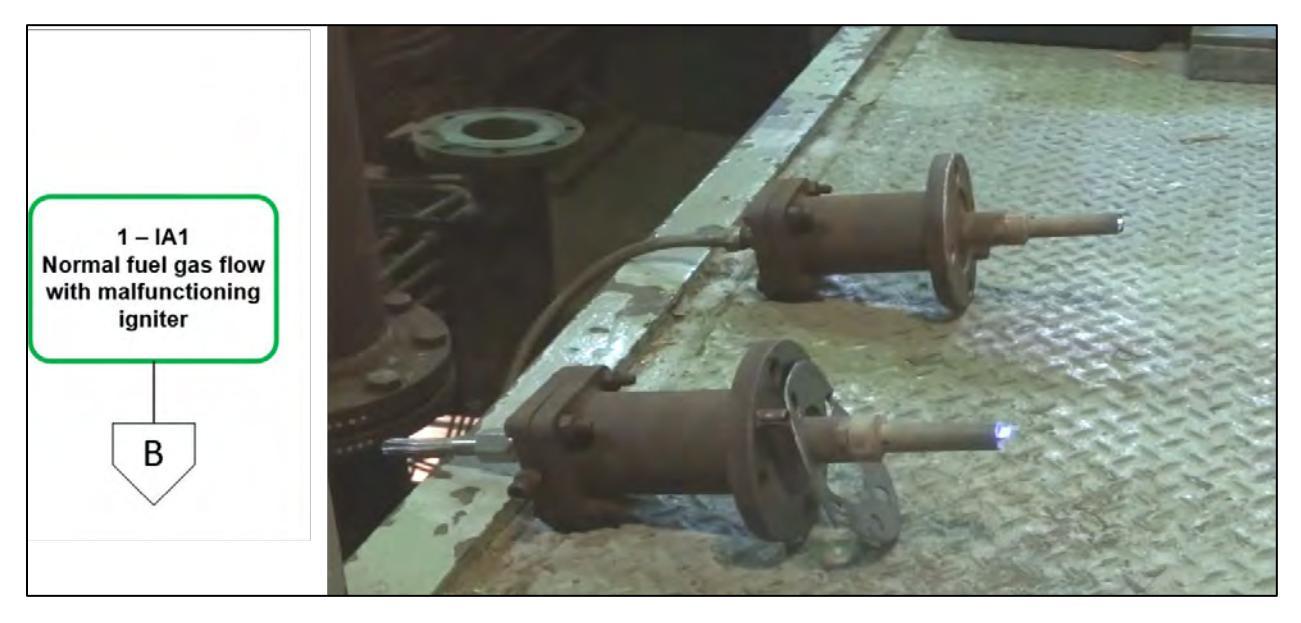
Figure 34. Turbine Generator 5 Ignitors During Test Simulation

During startup simulation testing the spark plugs were removed from TG 5 so that they could be observed during each simulation of the start-up sequence. Both spark plugs arced as anticipated during the simulations, as shown in Figure 34, and the air pressure that inserts the plugs into the combustion chamber during normal operation was also observed to be operating normally. The spark plugs operated as anticipated, therefore, normal gas flow with malfunction ignitor was contradicted and determined to have very low plausibility.

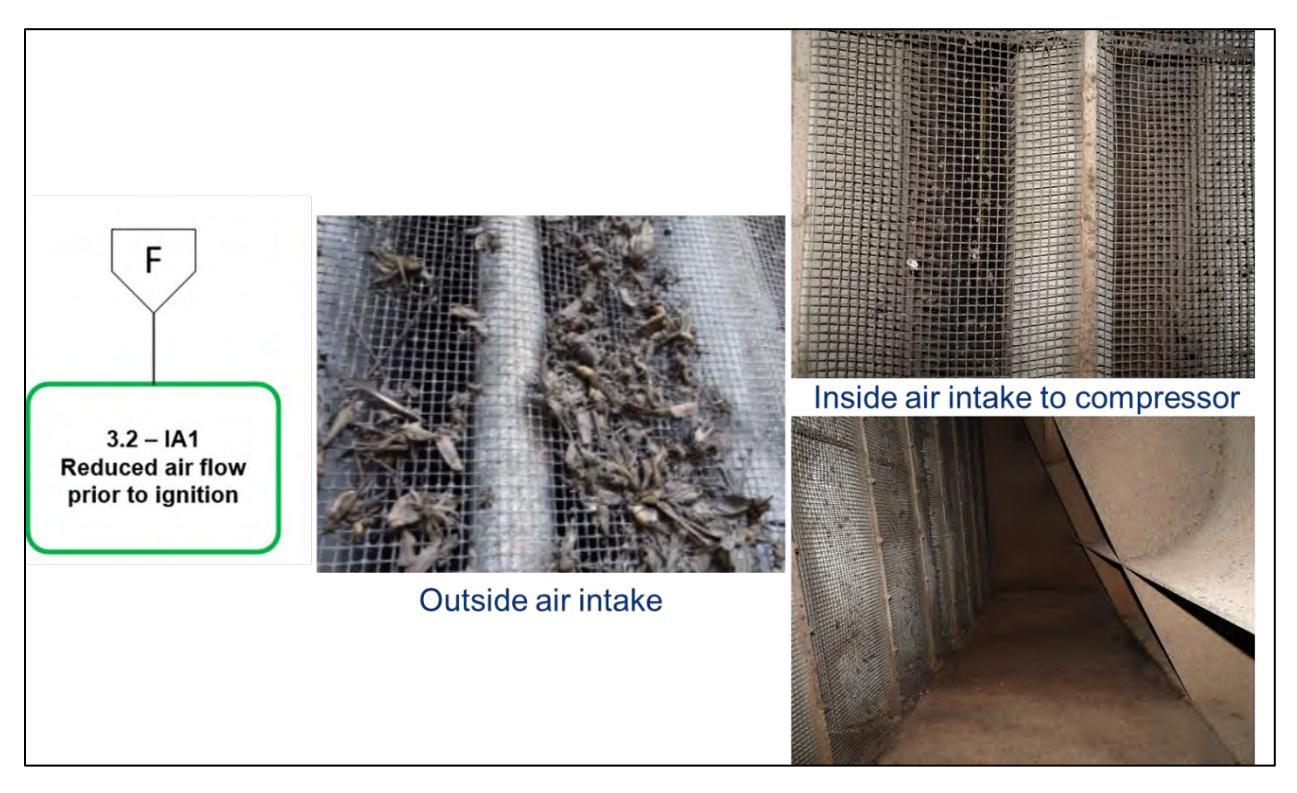
Figure 35. Compressor Air Intake Screen and Ducting

During the first post incident inspection of TG 5 in late December 2019 by ABS Group, an accumulation of insects on the turbine compressor air intake screen was observed. During as-found inspection the compressor air intake duct was opened behind the air intake screen for further inspection. Both the outside and inside of the compressor air intake are shown in Figure 35. During discussions between ABS Group, SWBNO, and General Electric, General Electric confirmed that a significant obstruction of compressor air intake flow would create a pressure drop and likely result in damage to the air intake ducting (e.g., collapsing the ductwork) as a result. Because no foreign objects or insects were observed behind the air intake screen, the insects appeared to have been in place for a substantial amount of time (longer than the period of time between the December 12th and 14th startups), and the lack of observable damage to the compressor air intake ducting, reduced compressor intake air flow was contradicted and determined to have very low plausibility.

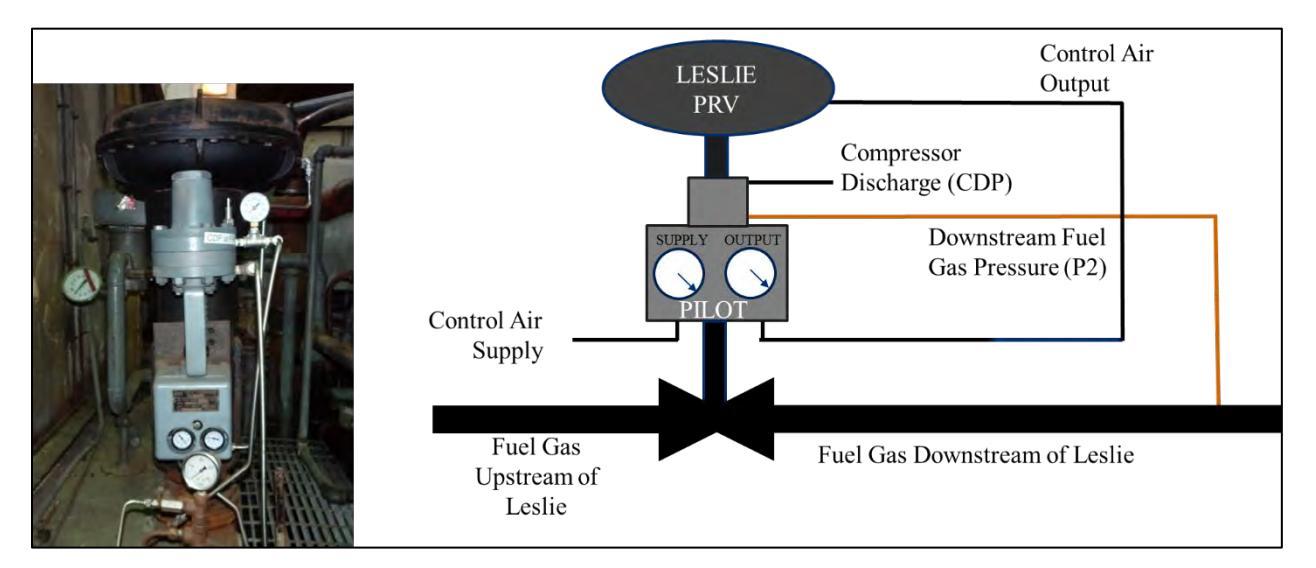
Figure 37. Turbine Generator 5 Gas Pressure Ratio Valve and Pilot

The gas pressure ratio valve and pilot, shown in Figure 37, regulates the downstream fuel gas pressure before the stop valve, based on compressor discharge pressure (CDP). The pilot valve inputs include: (1) control air supply, specified to be 20 psi +/- 0.5 psi as discussed in Section 5.1, (2) turbine CDP, and (3) downstream fuel gas pressure before the stop valve (P2). The control output is control air to the gas pressure ratio pilot valve to adjust the gas pressure ratio valve position to achieve the regulated downstream fuel gas pressure, P2.

Replace both the gas pressure ratio valve and pilot with a modern gas ratio valve and controller.

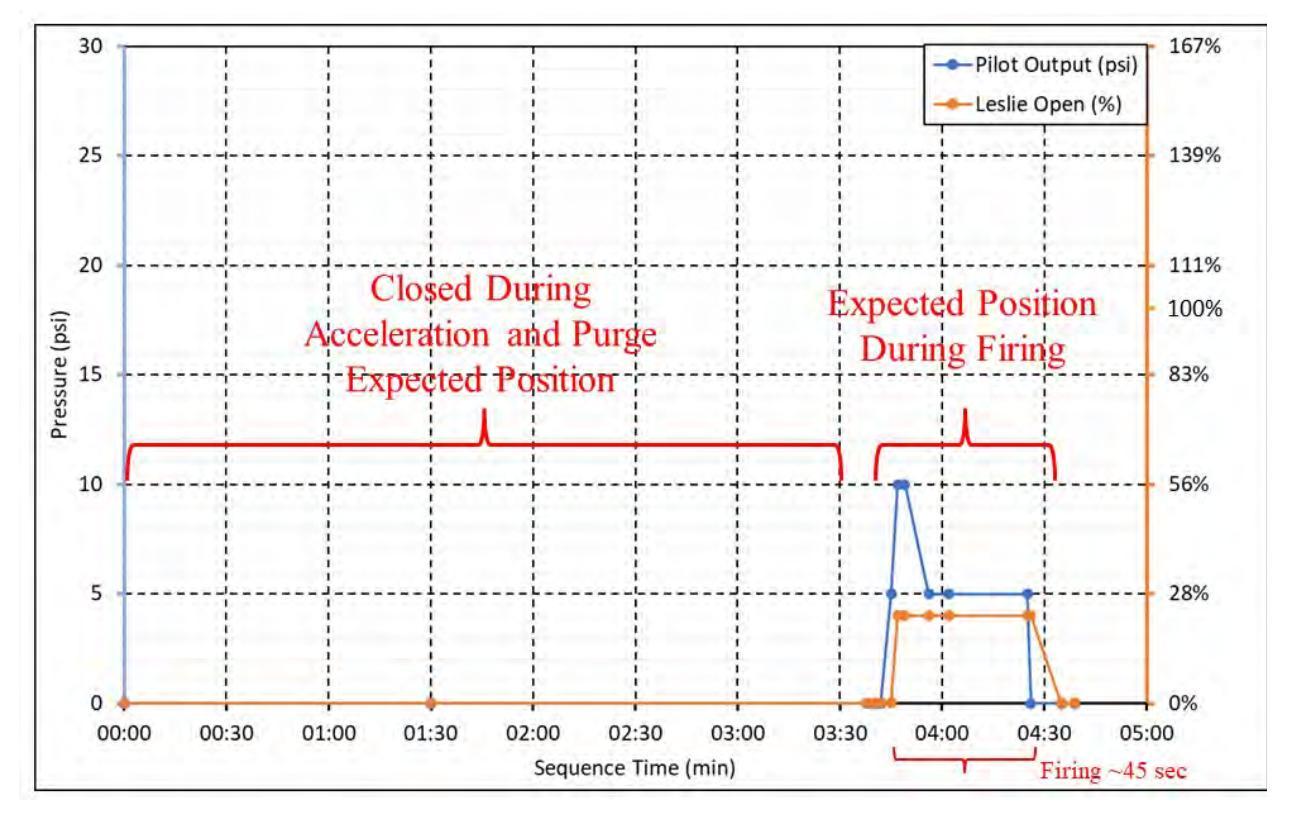
Figure 45. Test Scenario 1 - Gas Pressure Ratio Valve Position and Pilot Output Pressure

Results for test scenario 1, plotted in Figure 45, indicate that when the pilot is allowed to control the gas pressure ratio valve to a fully closed position prior to start-up of the turbine and prior to the firing sequence that both perform as expected with the pilot controlling the gas pressure ratio to approximately 25% open during the firing sequence.

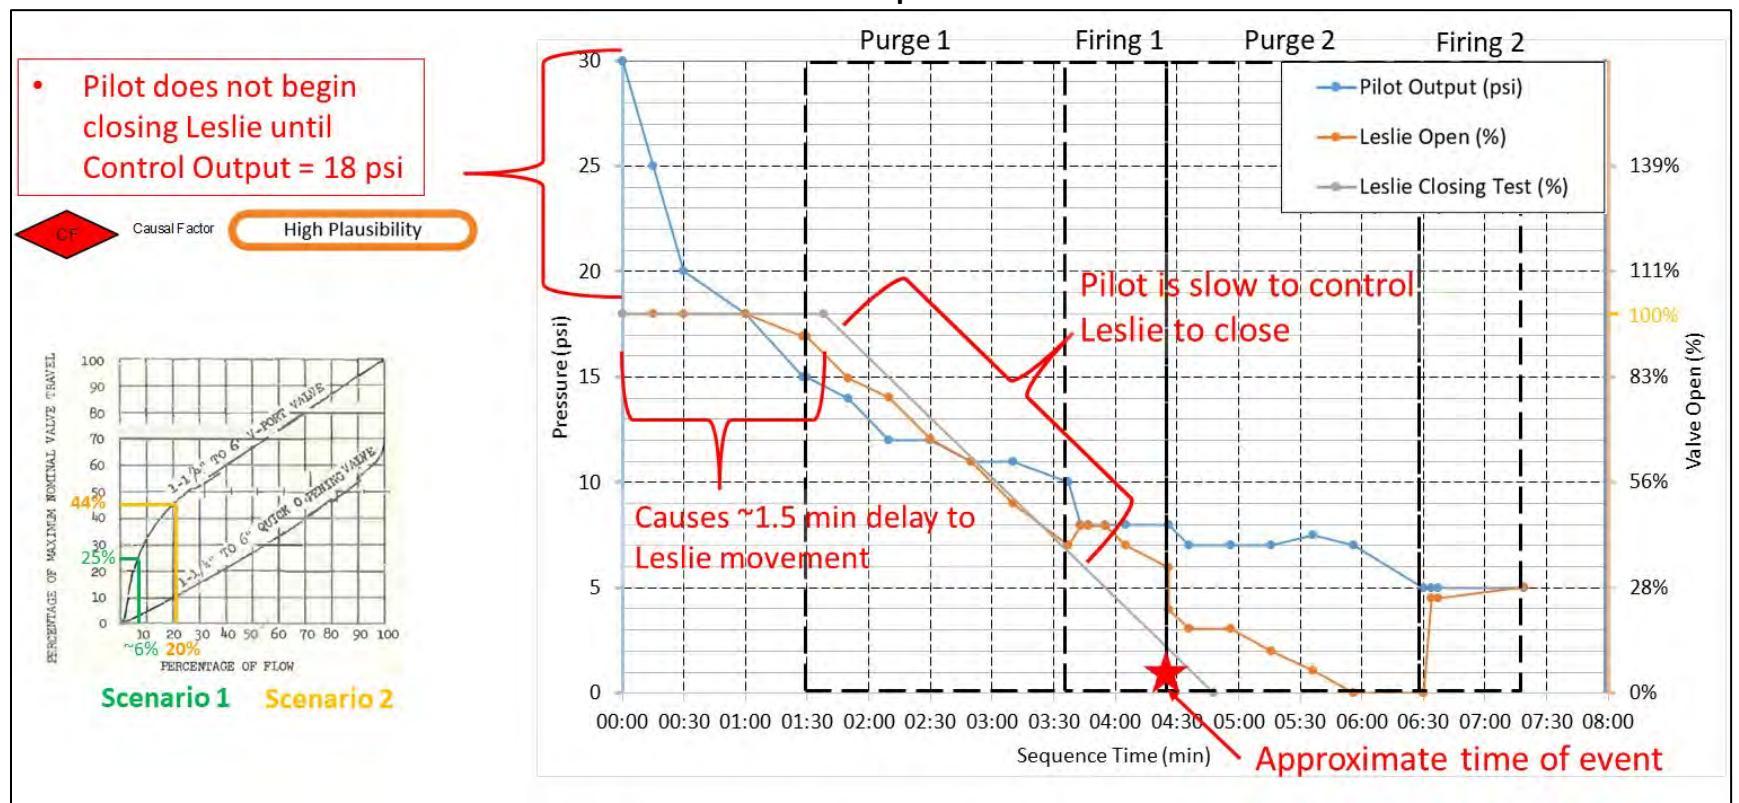
Figure 46. Test Scenario 2 - Gas Pressure Ratio Valve Position and Pilot Output Pressure

Results for test scenario 2, which represents the normal sequence for turbine startup, are presented in Figure 46. This reveals many facets of the as-found operation of the gas pressure ratio pilot. The pilot output control pressure, represented by the blue line in Figure 46, begins at the as-found control air supply pressure of \sim 30 psig and the gas pressure ratio valve remains 100% open until the control air output pressure drops to 18 psig. GEI-40960 page 676^[10], reproduced in Figure 47, shows a cross-section of the gas pressure ratio pilot and is stamped with "0-18 operational range 1.4 to 1 ratio". The 1.4 to 1 ratio is understood to be the linear slope of downstream fuel gas pressure to CDP and the 0 to 18 range is suspected to be the range of control pressures to manipulate the gas pressure ratio valve position. In any case, inspection of the scenario 2 test results in Figure 46 clearly indicate the gas pressure ratio valve position does not begin to respond to the pilot control pressures until it falls to 18 psig, consistent with the 0-18 range in Figure 47. The result is that the high input control air pressure identified in Section 5.1, results in the delayed onset of gas pressure ratio valve movement, which is the second causal factor. The third causal factor identified during test scenario 2 is that the pilot is slow to control the gas pressure ratio valve, as indicated by the time required for the pilot to control the gas pressure ratio valve position. This results in the gas pressure ratio valve being opened in excess of that required for firing of the turbine.

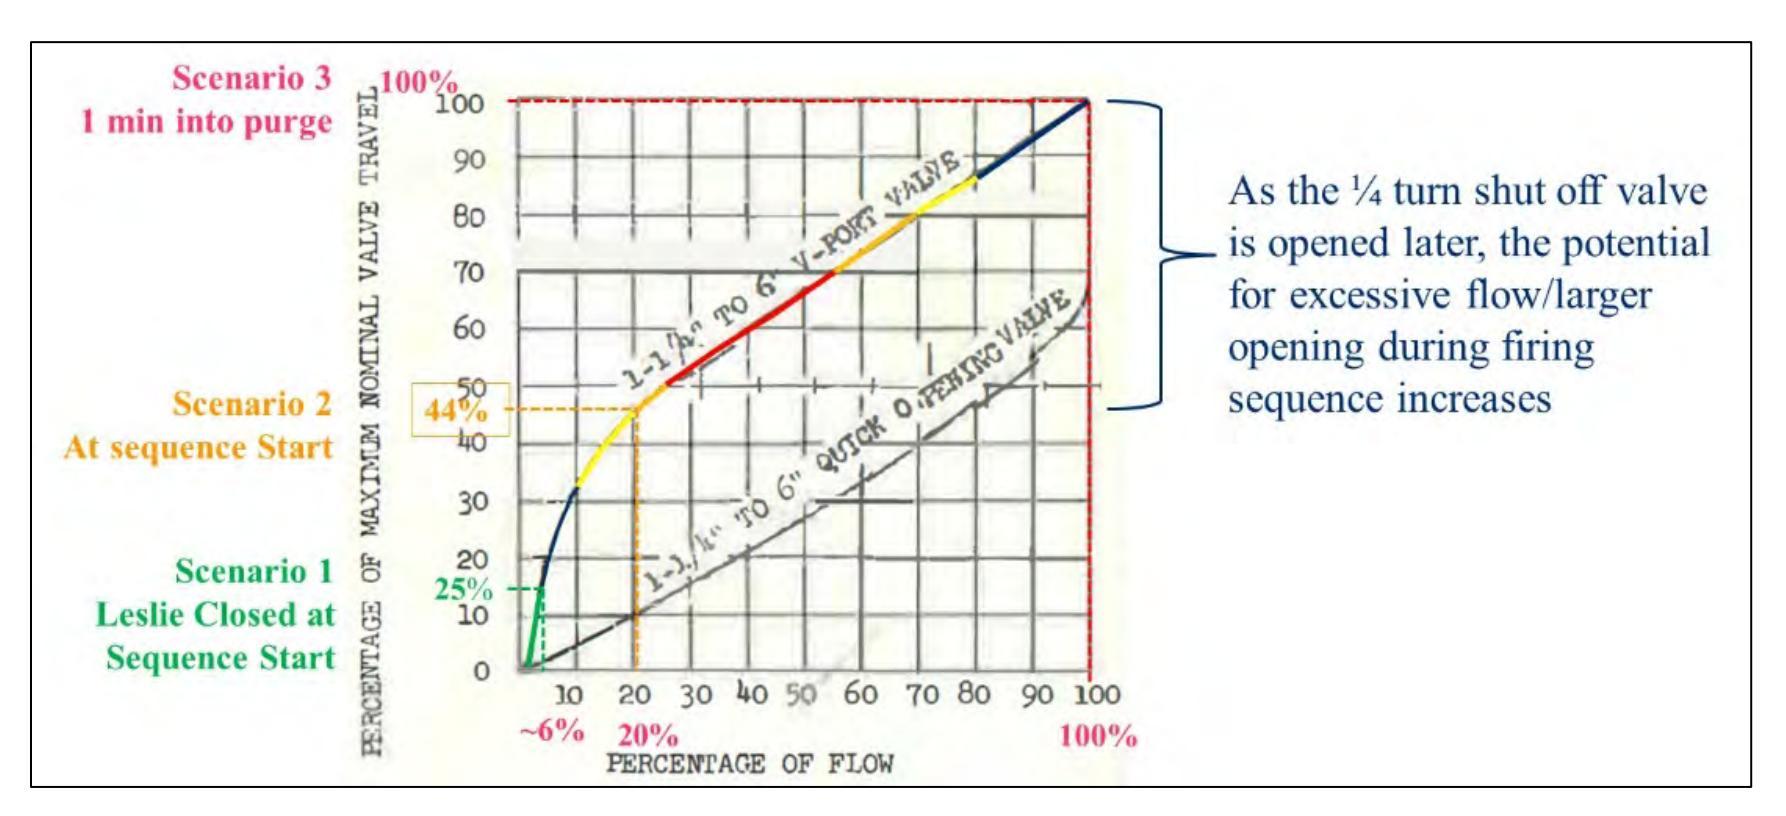
Figure 48. Test Scenarios - Gas Pressure Ratio Valve Travel vs Percentage of Fuel Gas Flow

Test scenario 3, opening the ¼ turn valve late, results in an even larger opening position of the gas pressure ratio valve at the onset of firing as illustrated in Figure 48, which is the fourth causal factor.

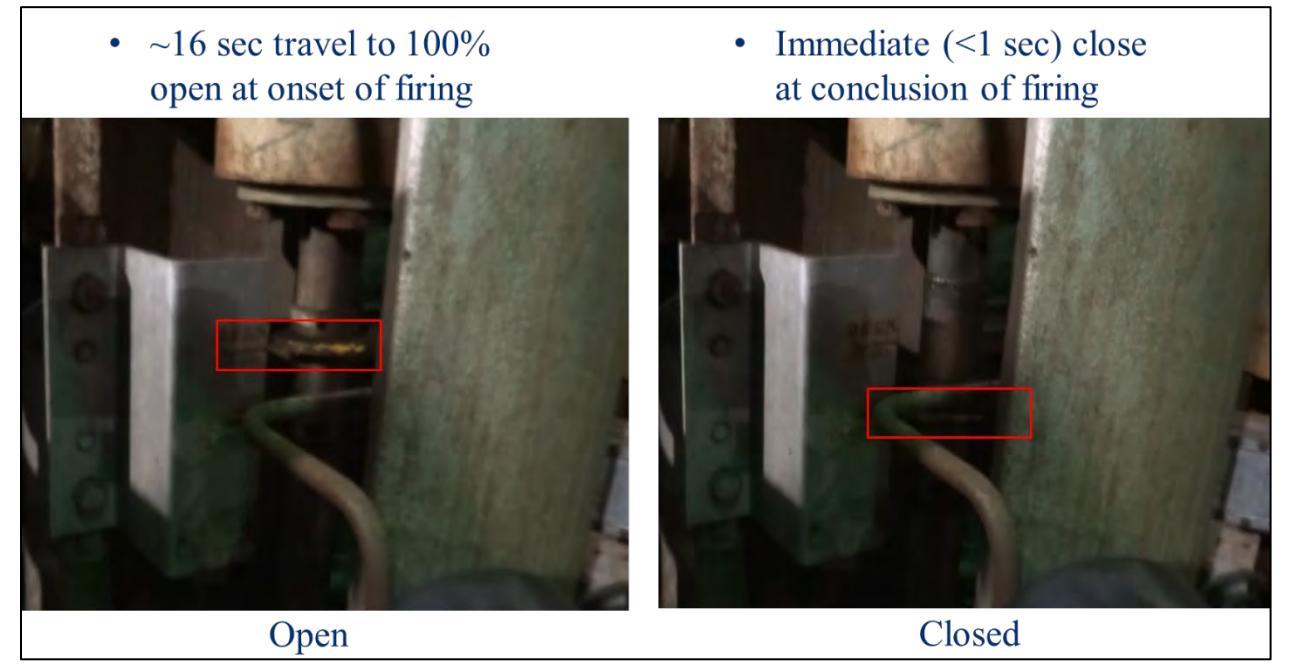
Figure 49. Fuel Gas Stop Valve Operation During Start-up Simulation

A leak test was also performed by opening the ¼-turn shutoff valve, pressurizing the volume upstream of the stop valve, then closing the ¼-turn shutoff valve and monitoring the pressure between the ¼-turn shutoff valve and the stop valve over a period of 10 minutes. Table 13 shows that the rate of pressure decay was approximately 1 psi per minute and a total of 10 psi over the duration of the 10 minute test as shown in Figure 50. The volume of piping between the two valves is relatively small and the rate of gas leakage low.

The fuel gas stop valve performance was nominal. Therefore, malfunction of the fuel gas stop valve was contradicted and determined to be very low plausibility.
