THE SEWERAGE AND WATER BOARD OF NEW ORLEANS

CARROLLTON WATER PLANT TURBINE GENERATOR 5 EXPLOSION INCIDENT December 14, 2019 CAUSAL ANALYSIS AND RECOMMENDATIONS FINAL REPORT

30 November 2020 PS-**4429639** Contract: 0001505

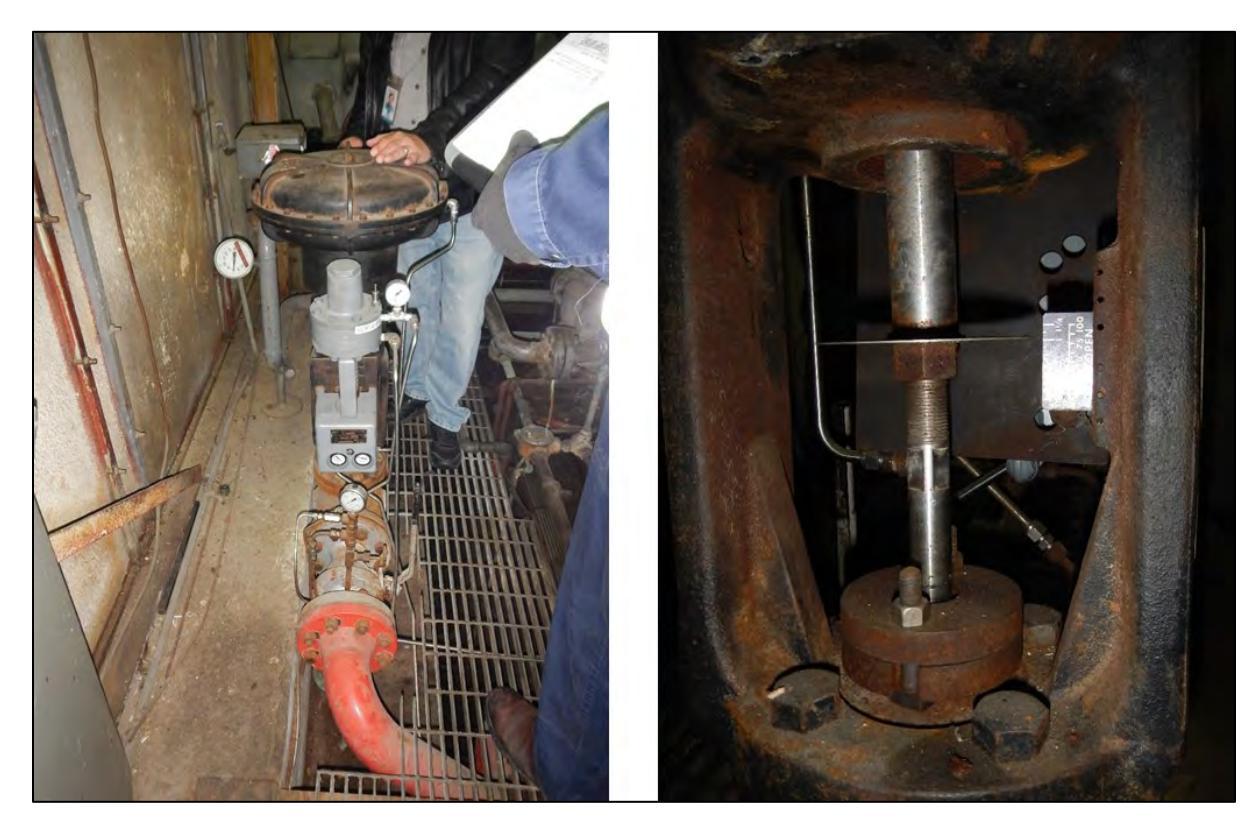
Figure 23. Fuel Gas Pressure Ratio Valve (Open Position) and Pilot (Grey)

Phase 2 of the outage began after damage occurred to the starting motor clutch hubs^[10]. After the repairs, several startup attempts were made, and repairs were made to several electrical controls and mechanical systems. After many failed startup attempts, the turbine was successfully started by bypassing the gas pressure ratio pilot valve with instrument air noting that the gas pressure ratio pilot valve required further inspection and testing. Phase 2 of the outage concluded, and Phase 3 work began. Phase 3 work included repairing the gas pressure ratio pilot valve, which was inspected and repaired by John H. Carter Company^[10]. The gas pressure ratio pilot valve required repair of a broken spacer and replacement of the diaphragm^{[10],[11]}.

After repair of the gas pressure ratio pilot valve, startup troubleshooting continued. Troubleshooting then occurred with getting the turbine to come up to speed when taking load, Adjustments were made

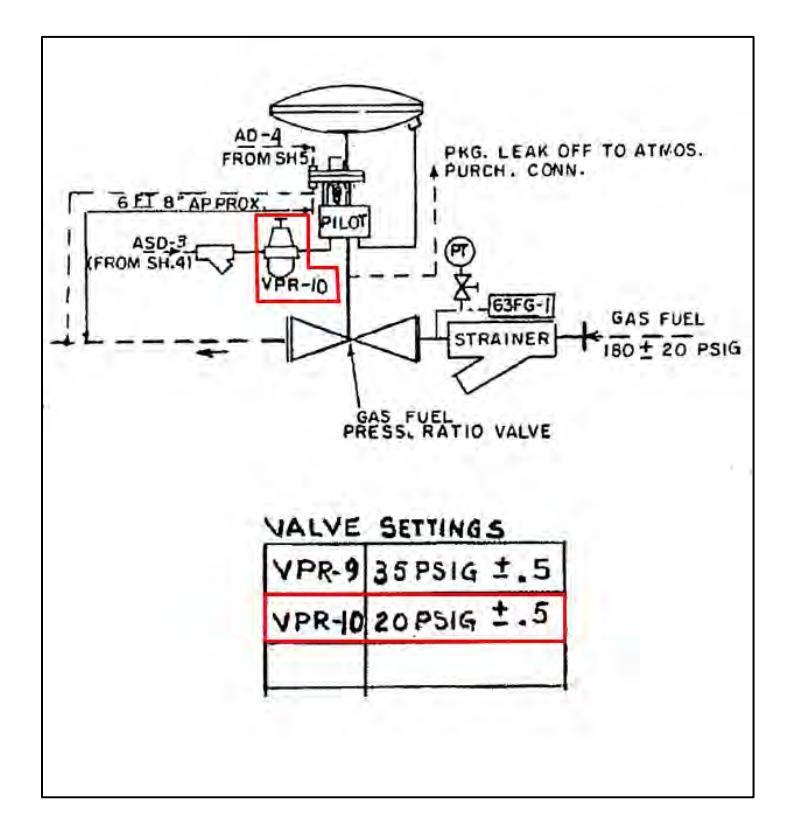
Figure 32. VPR-10 Specified Valve Settings

During as-found documentation of the turbine and equipment, control air to the turbine was restored and the pneumatic controls identified in Table 5 of Section 2.1.2 were inspected. All VPRs were observed to be within reasonable limits of the specified settings from the schematic piping diagrams with the exception of VPR-10 as shown in the two right hand columns in Table 10. VPR-10 is the control air supply for the gas pressure ratio pilot valve. The specified value is 20 psig ⁺/- 0.5 psi as shown from the schematic piping diagram in Figure 32 and the pressure was observed to be 30 psi at the VPR-10 regulator and 35 psi as measured by the pilot supply pressure gage as shown from photographs taken during the as found inspection in Figure 33.

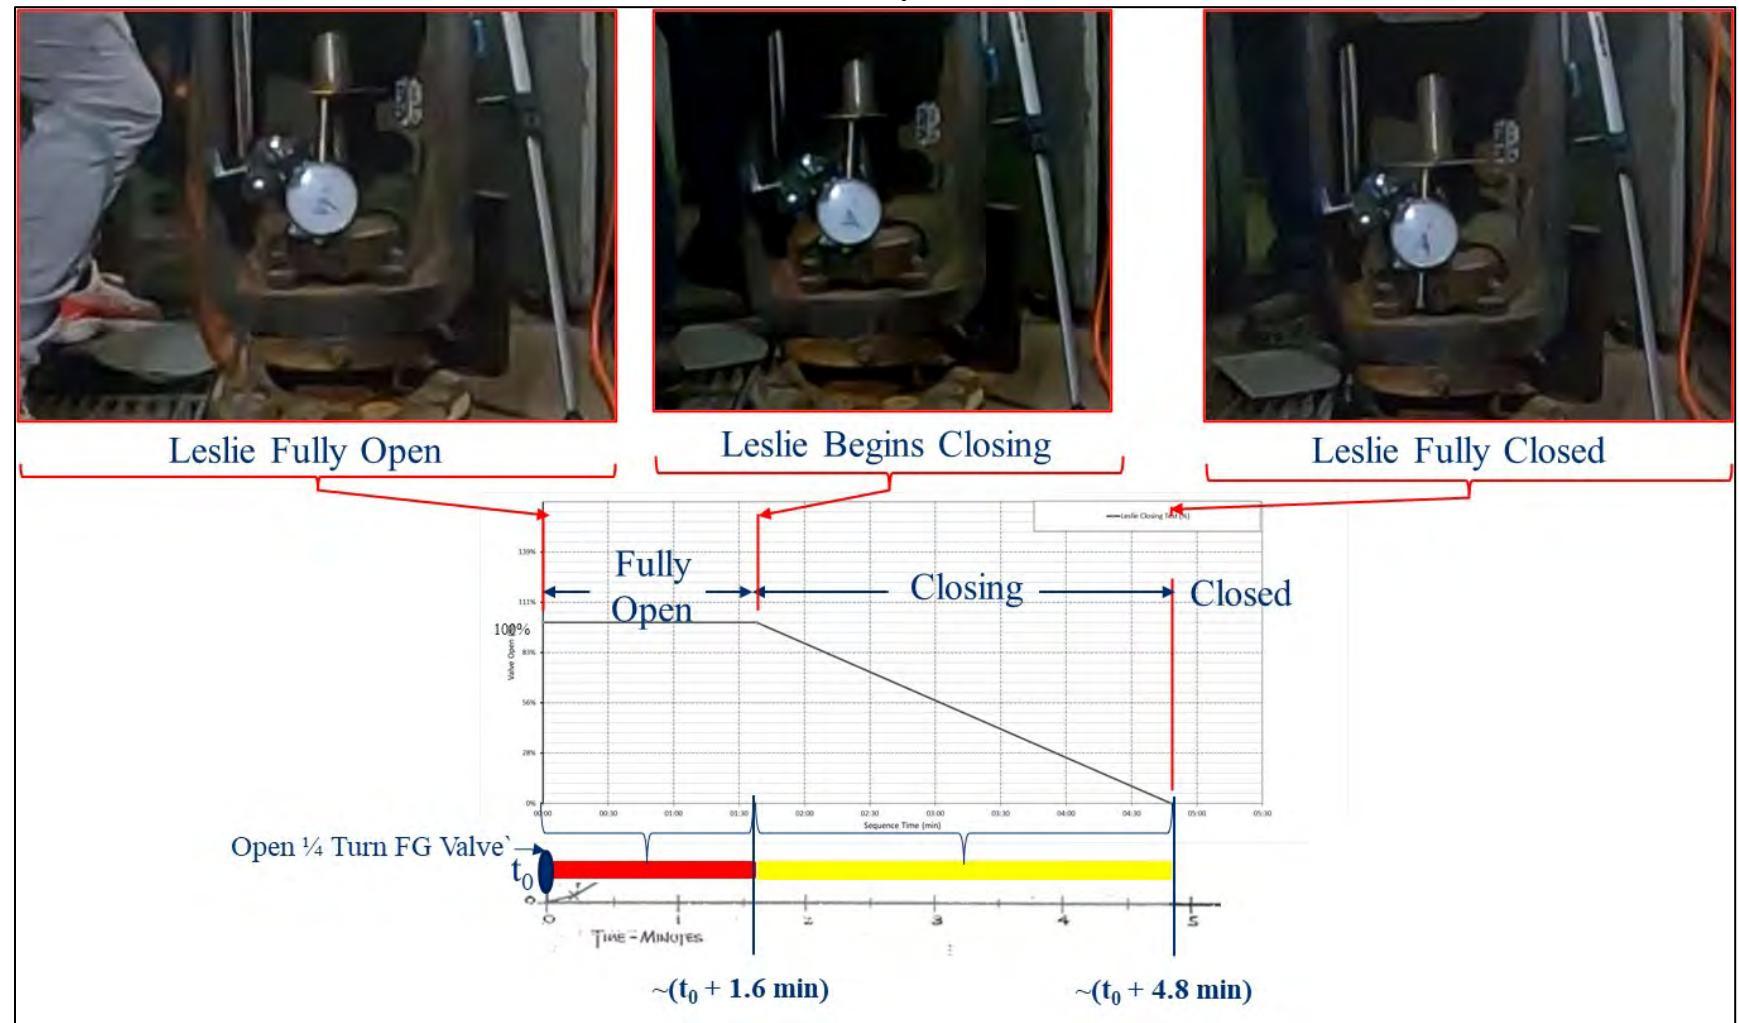
Figure 43. Gas Pressure Ratio Valve Position vs Time after Establishing Fuel Gas Pressure

After establishing fuel gas pressure by opening the ¼ turn shutoff valve, the gas pressure ratio valve position remained 100% open for ~1.6 minutes and then required an additional ~3.2 minutes to fully close as shown in Figure 43. The total time after opening the ¼ turn shutoff valve until the gas pressure ratio valve achieved the fully closed position was ~4.8 minutes.

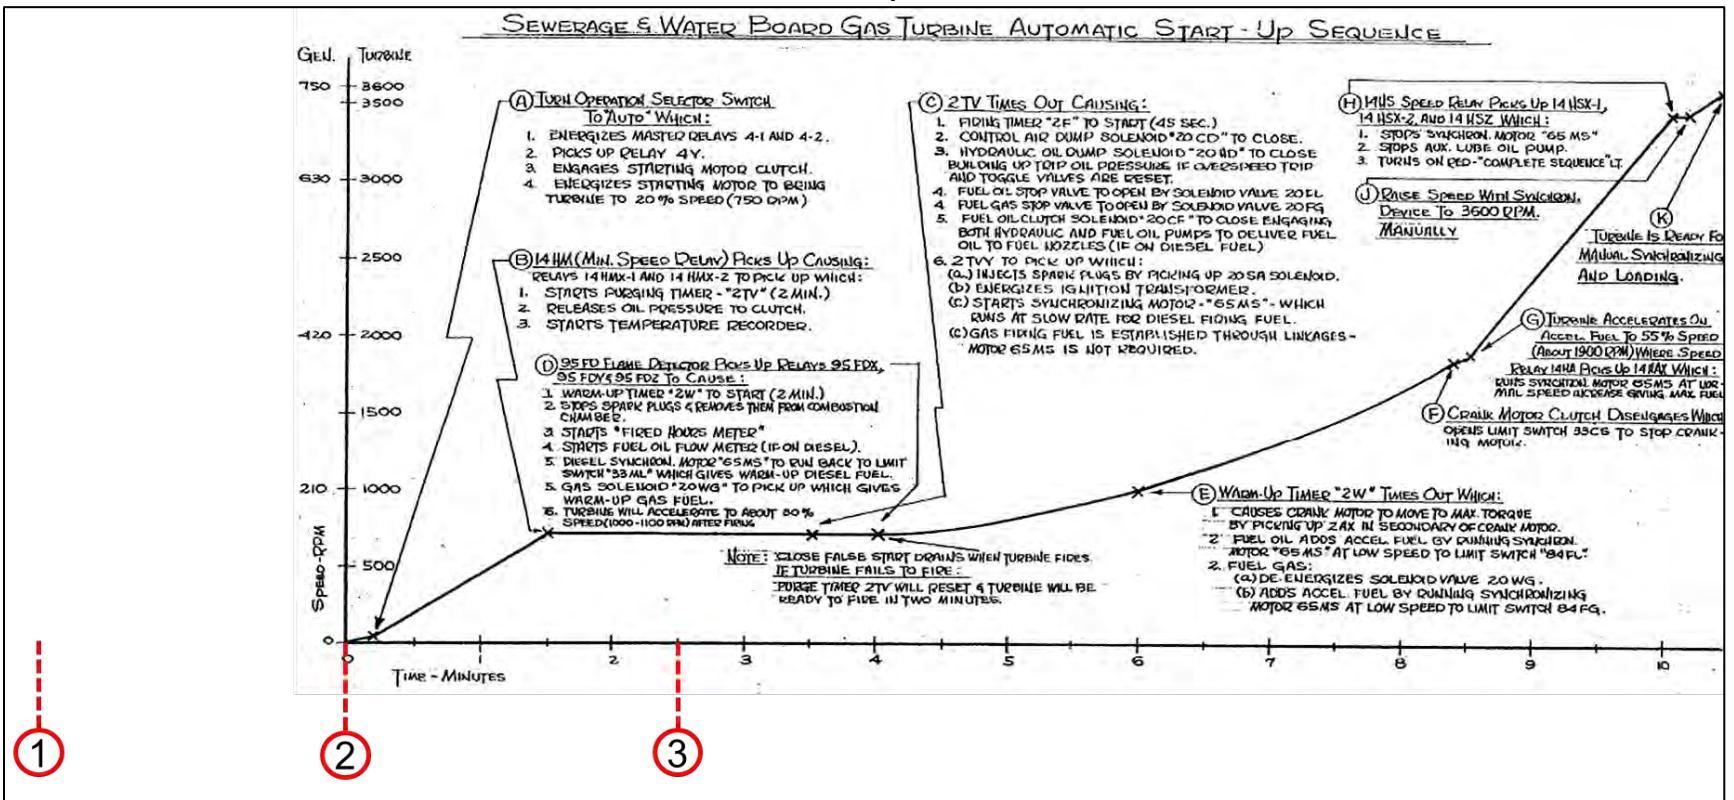
Figure 44. Automatic Start Up and Test Scenario – Establishment of Fuel Gas Pressure

Three start-up scenarios were simulated during testing as detailed in Table 12. First, the ¼-turn shutoff valve was opened, and the pilot allowed to control the gas pressure ratio valve to the fully closed position prior to initiating the start-up simulation. This is not the standard operating method; however, it does allow the gas pressure ratio valve to achieve the expected pre-start-up position, which is fully closed. Second, the ¼-turn shutoff valve was opened 1.5 minutes prior to the beginning of the purge sequence. This is approximately the time it takes the TG to accelerate to ~ 750 rpm by the cranking motor. This was performed to simulate the SWBNO operating procedure of opening the ¼-turn shutoff valve immediately prior to starting the turbine. Finally, the ¼ -turn shutoff valve was opened late, 1 minute into the purge sequence. Pilot output control pressure signal and the position of the gas pressure ratio valve were plotted versus the sequence time as shown on the start-up diagram in Figure 44.
